Coastal Protection and Restoration Authority of Louisiana

2010/2011 Annual Inspection Report

EAST SABINE LAKE HYDROLOGIC RESTORATION PROJECT (CS-32)

October 6, 2010
May 10, 2011
Cameron Parish

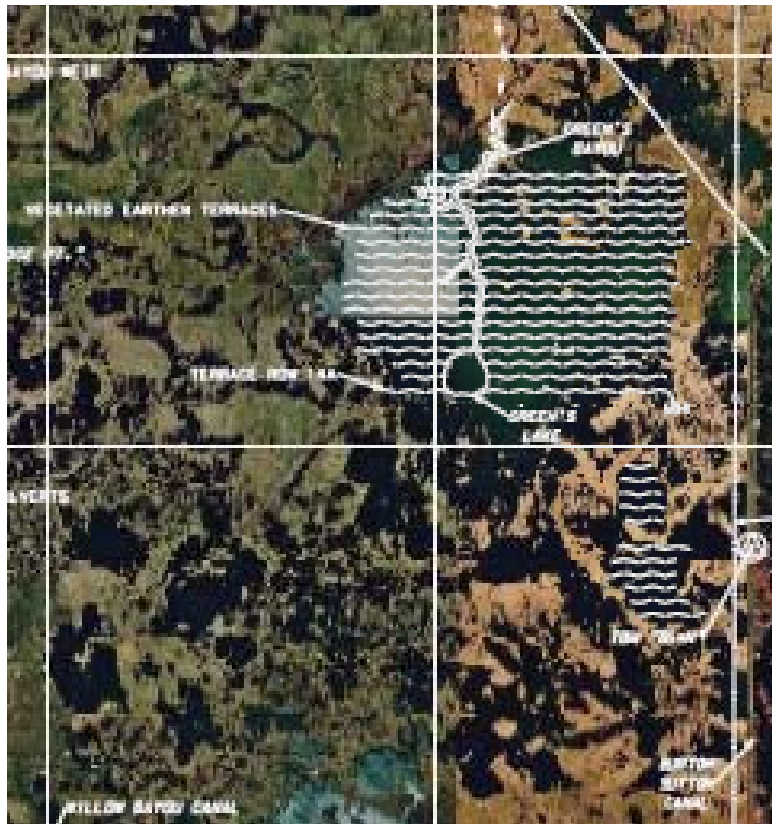
Figure 1. CU-1 contract plan for 171,000 LF terraces and vegetative plantings.

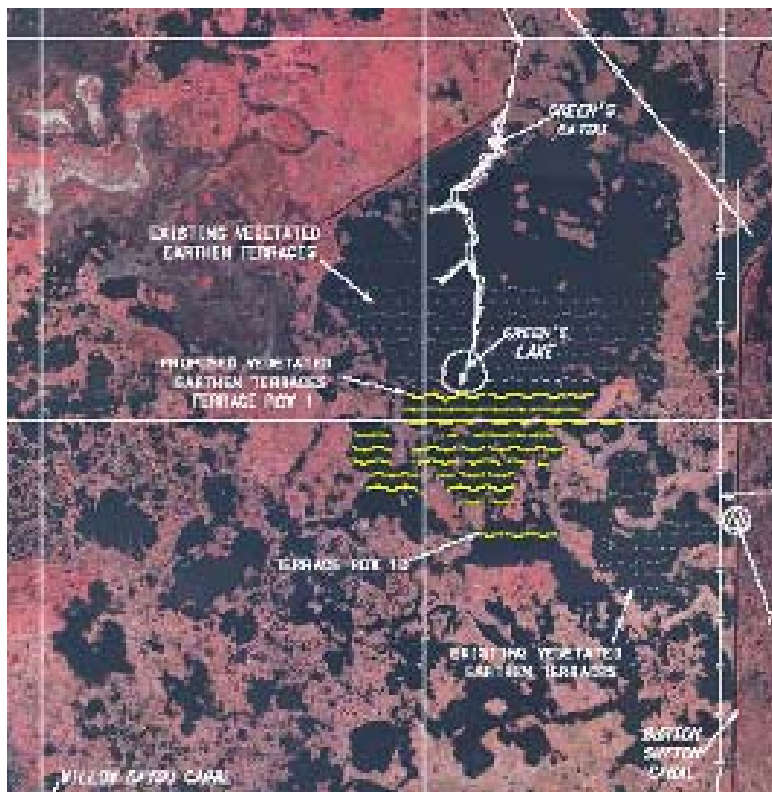
Figure 2. CU-1A contract plan for 50,000 LF terraces and vegetative plantings.

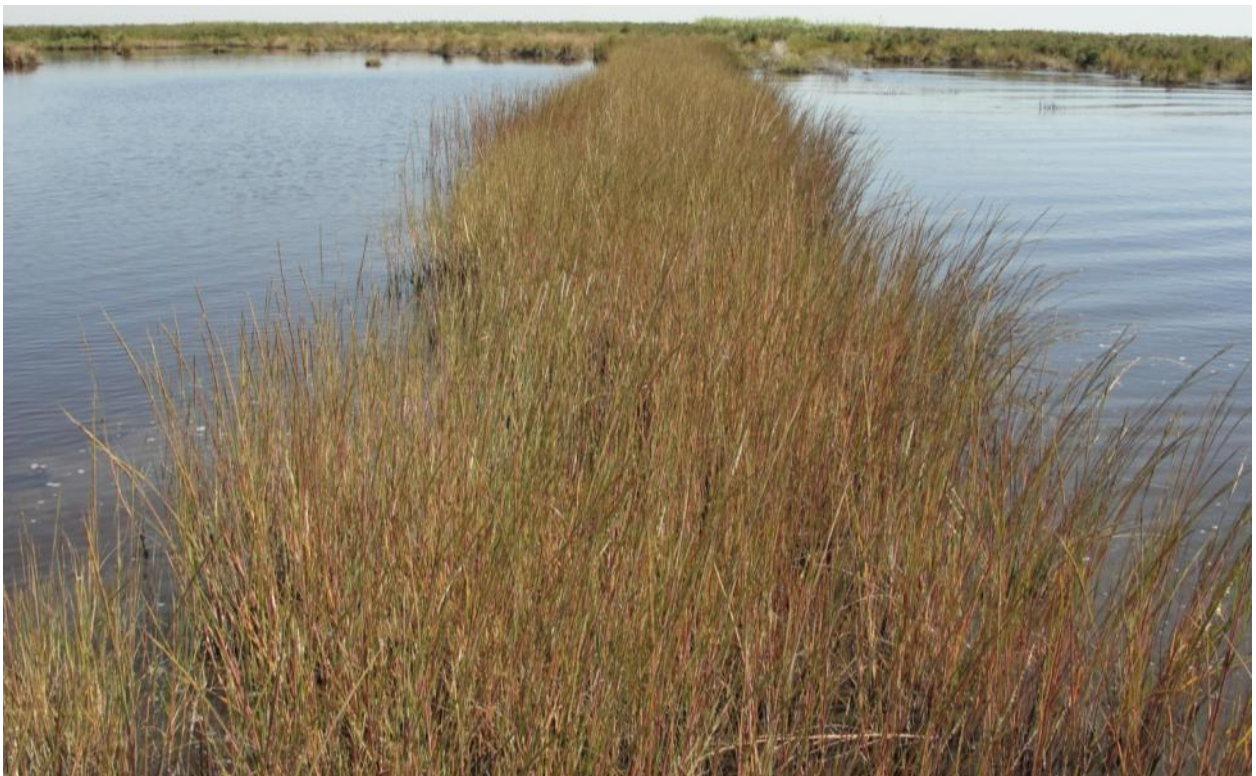
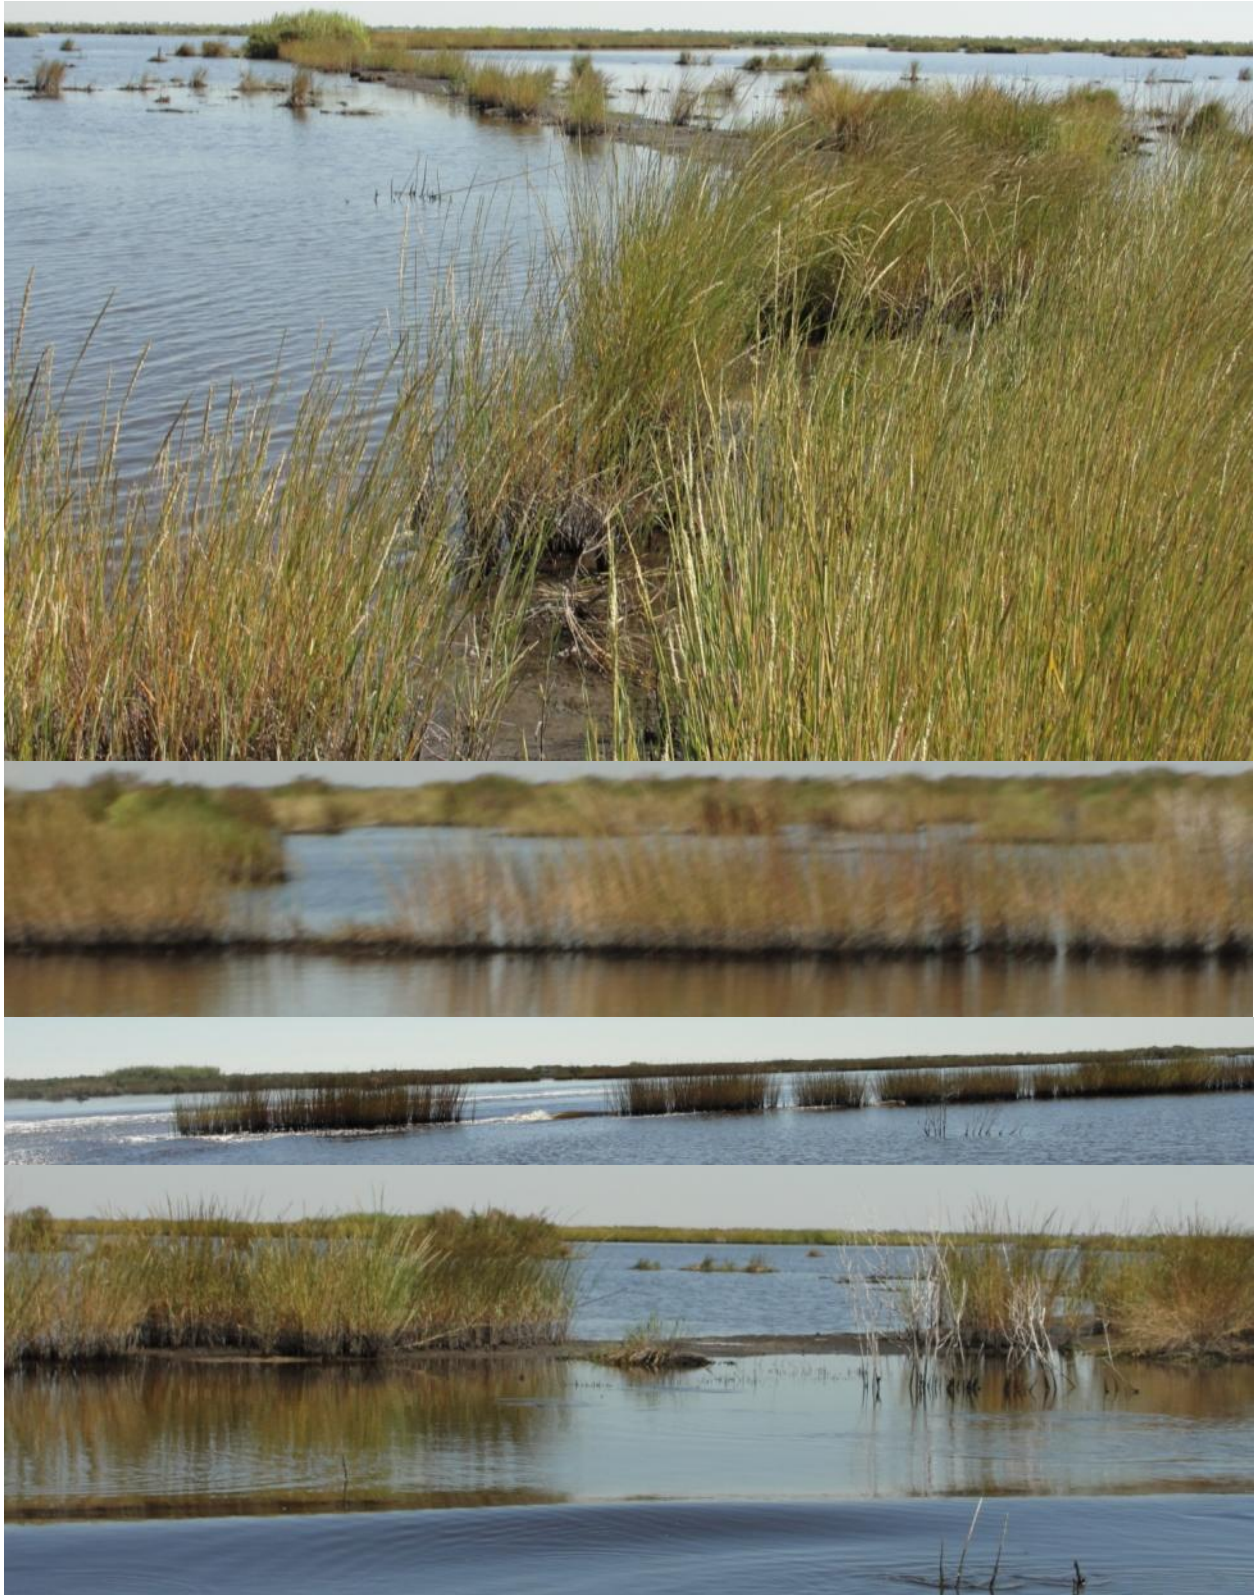
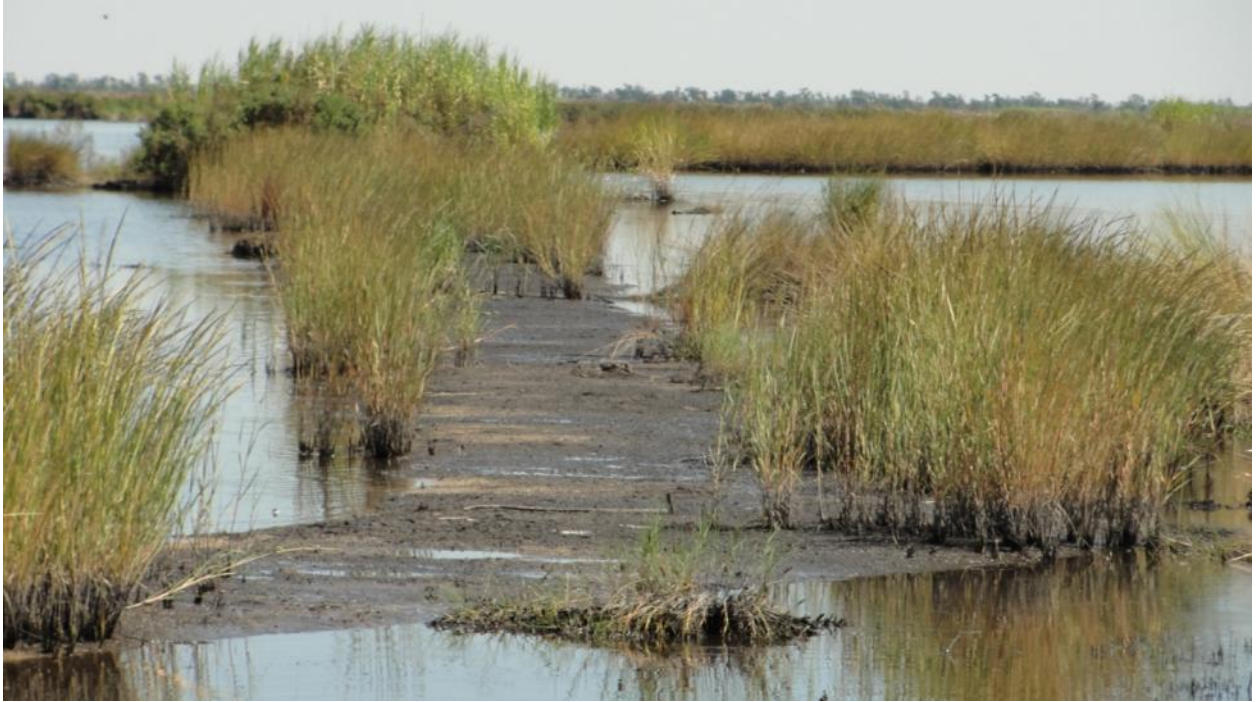
The estimated survival of the newer CU-1A/B plantings was very good in Rows 5 to 11 (greater than 80%), although the size of the gaps were more significant and narrowing of some terrace segments became more noticeable as we neared Row 5.

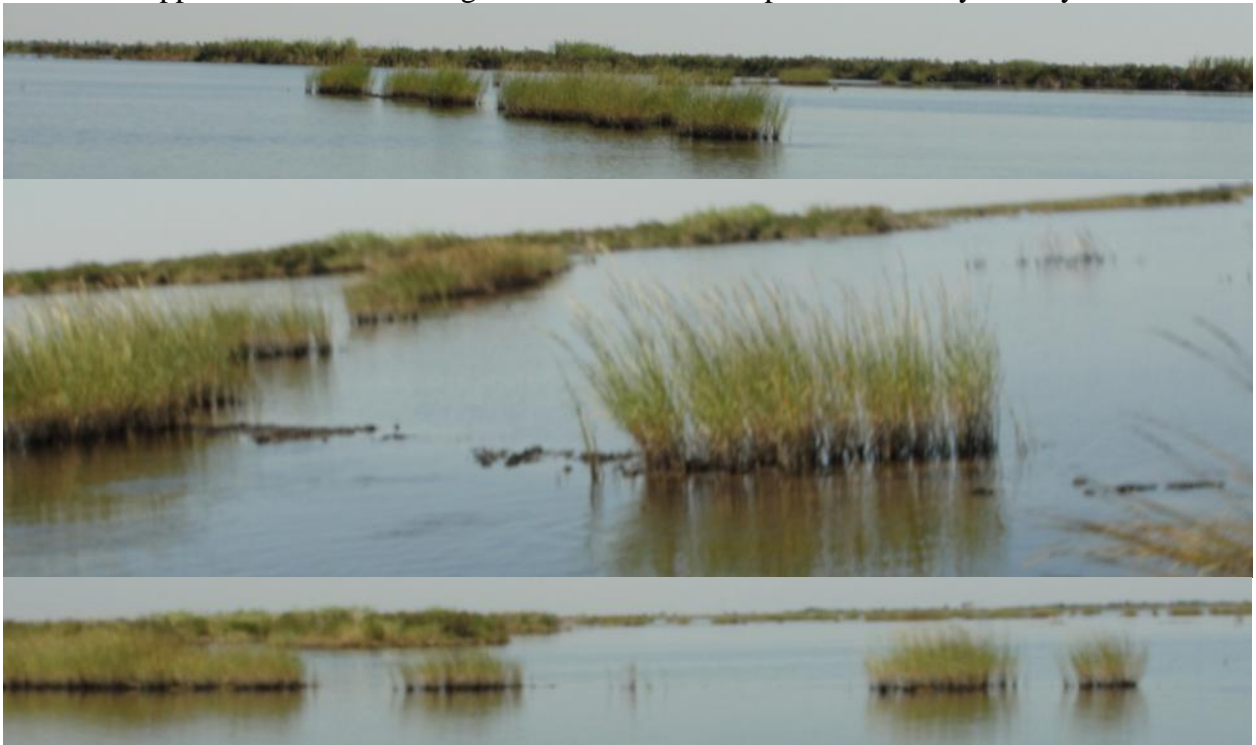
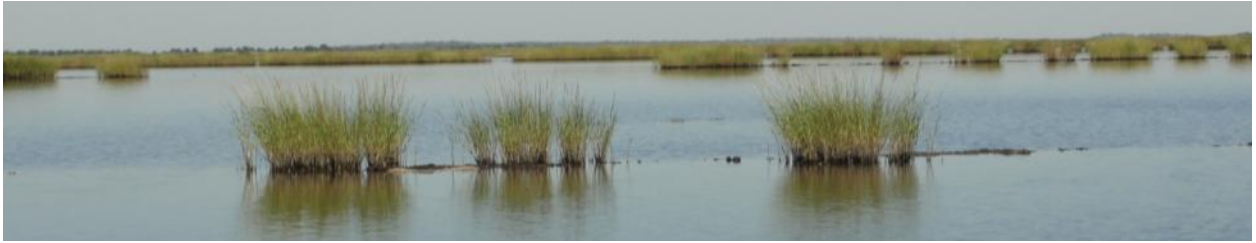
As the party continued north, the survival estimates for the rows dropped dramatically and ranged from fair to poor (5% to 50%) on the CU-1A/B Rows 4 to 2, but the vegetation that did remain appeared to be recovering well and for the most part looked very healthy.

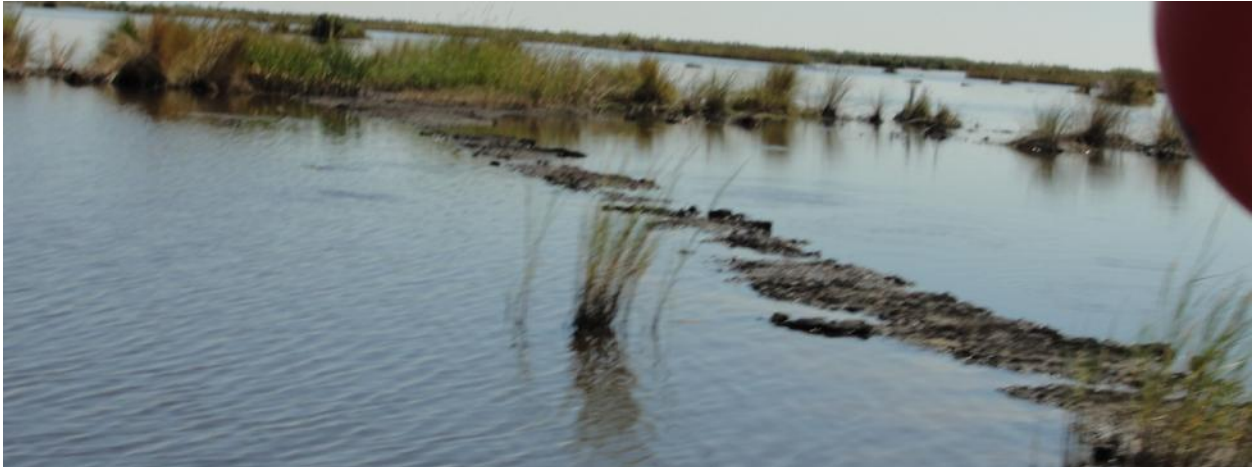
There were a few exceptions however where some plants appeared to be struggling, but those were generally found where the terrace segments were severely impacted and were obviously narrowed with lower crown elevation.

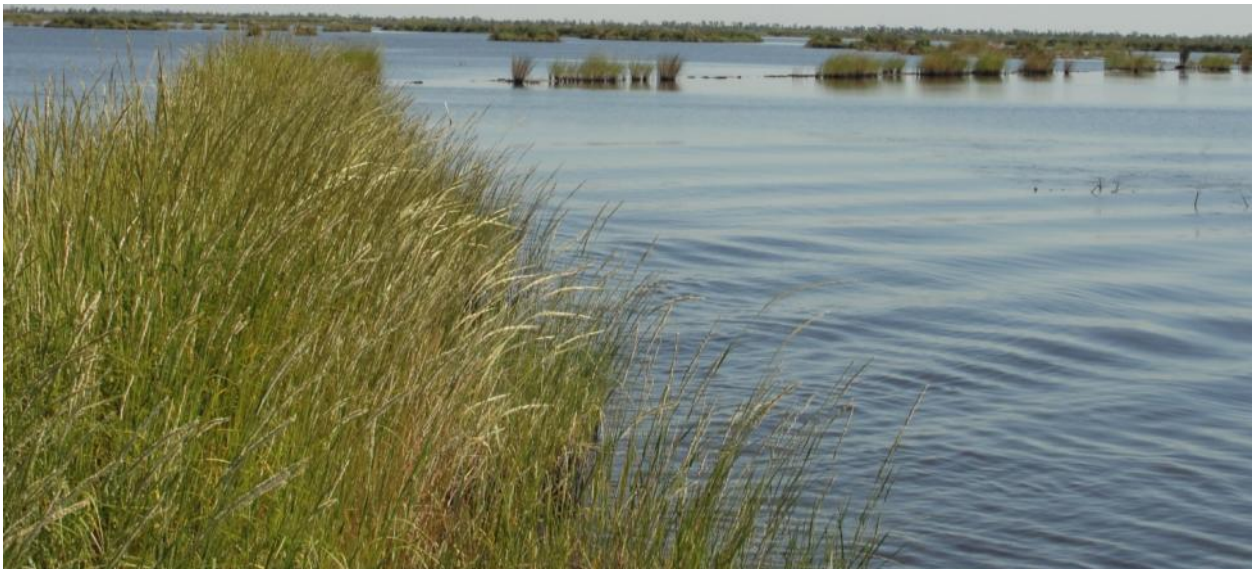
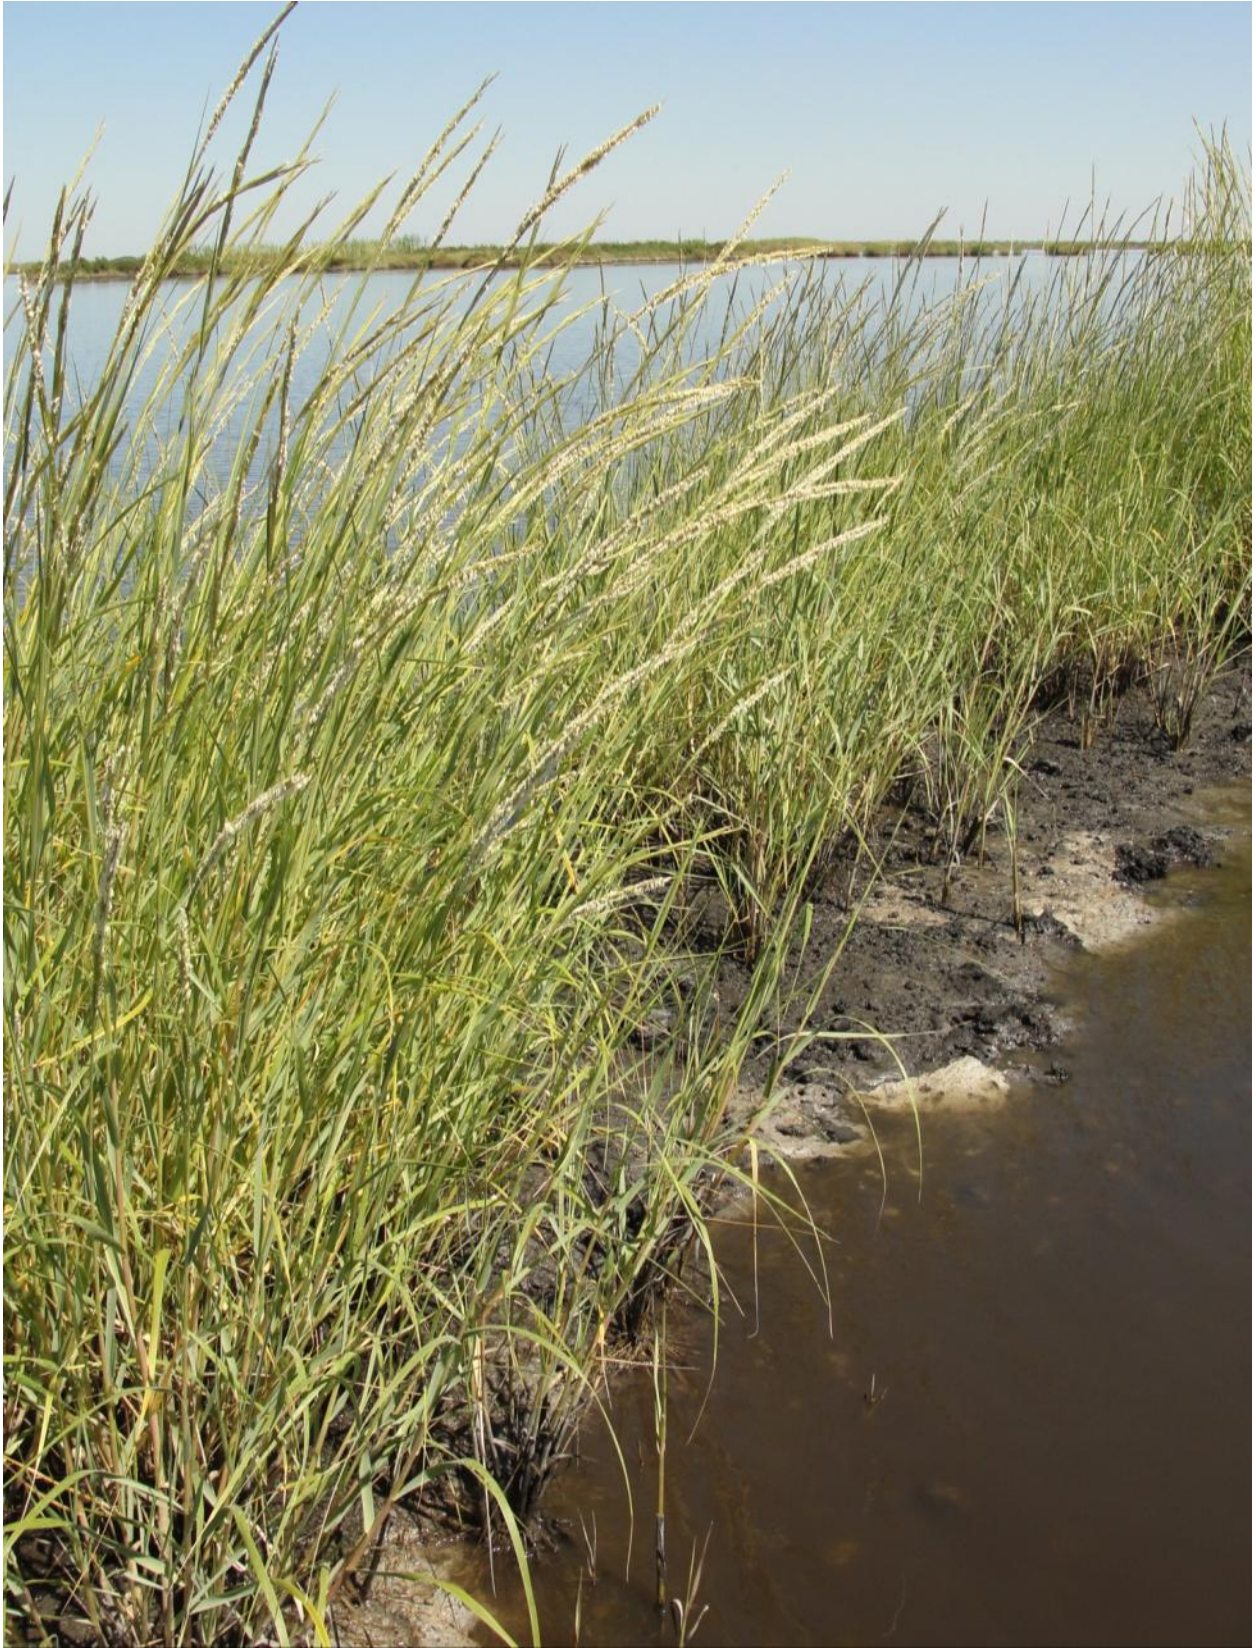
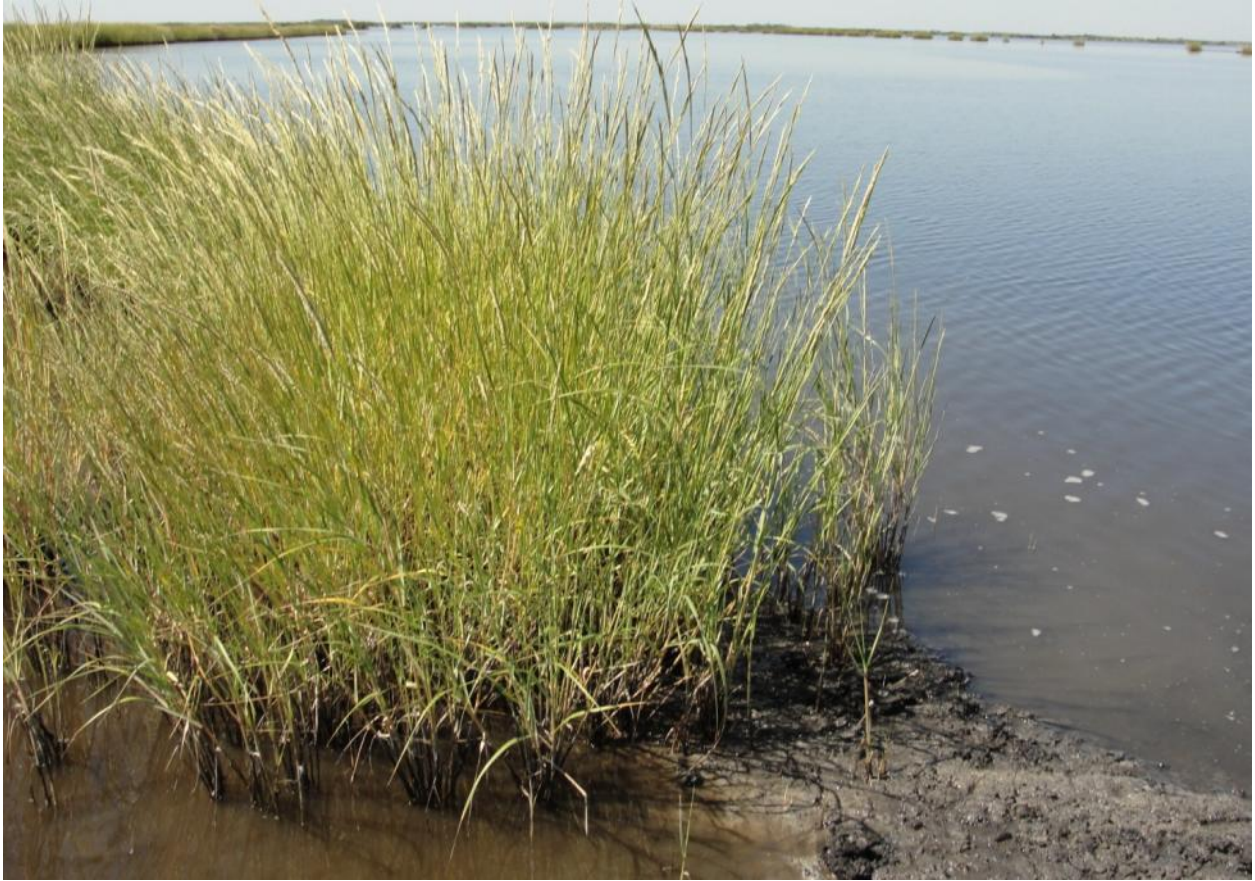
The survival on CU-1A/B Row 1, south of Green's Lake, was about 75%. Here again, the surviving plants looked very healthy and provided nearly 100% cover across the crown in some spots, but there were also other stretches bare of vegetation more than 100 feet long on this row.

Recommendation: The project team discussed options and it is recommended that the construction phase of this project be closed out. The remaining plantings are expected to continue to recover and expand but where there are large stretches of missing plants, it is advisable to re-vegetate with additional plantings that can be conducted through O&M. I recommend that an O&M planting to target areas with poor to no cover be planned for TY1 or 2, and could probably be accomplished for less than \$100,000 (not amortized \$). To provide for adequate cover to be maintained throughout the 20-year project life, O&M funds should also be available for an additional O&M planting event if it becomes necessary later in the project life. Darryl Clark has confirmed that there currently is \$254,428.04 in the project O&M budget, which is sufficient to fund a TY1 or 2 planting. OCPR typically implements the O&M activities, but if USFWS & OCPR agree, NRCS can design and implement the planting.

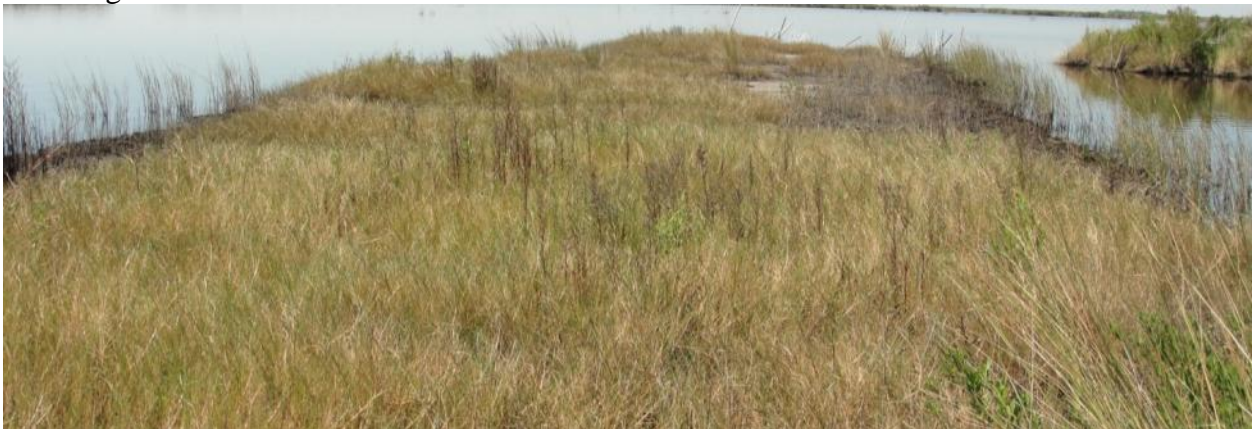
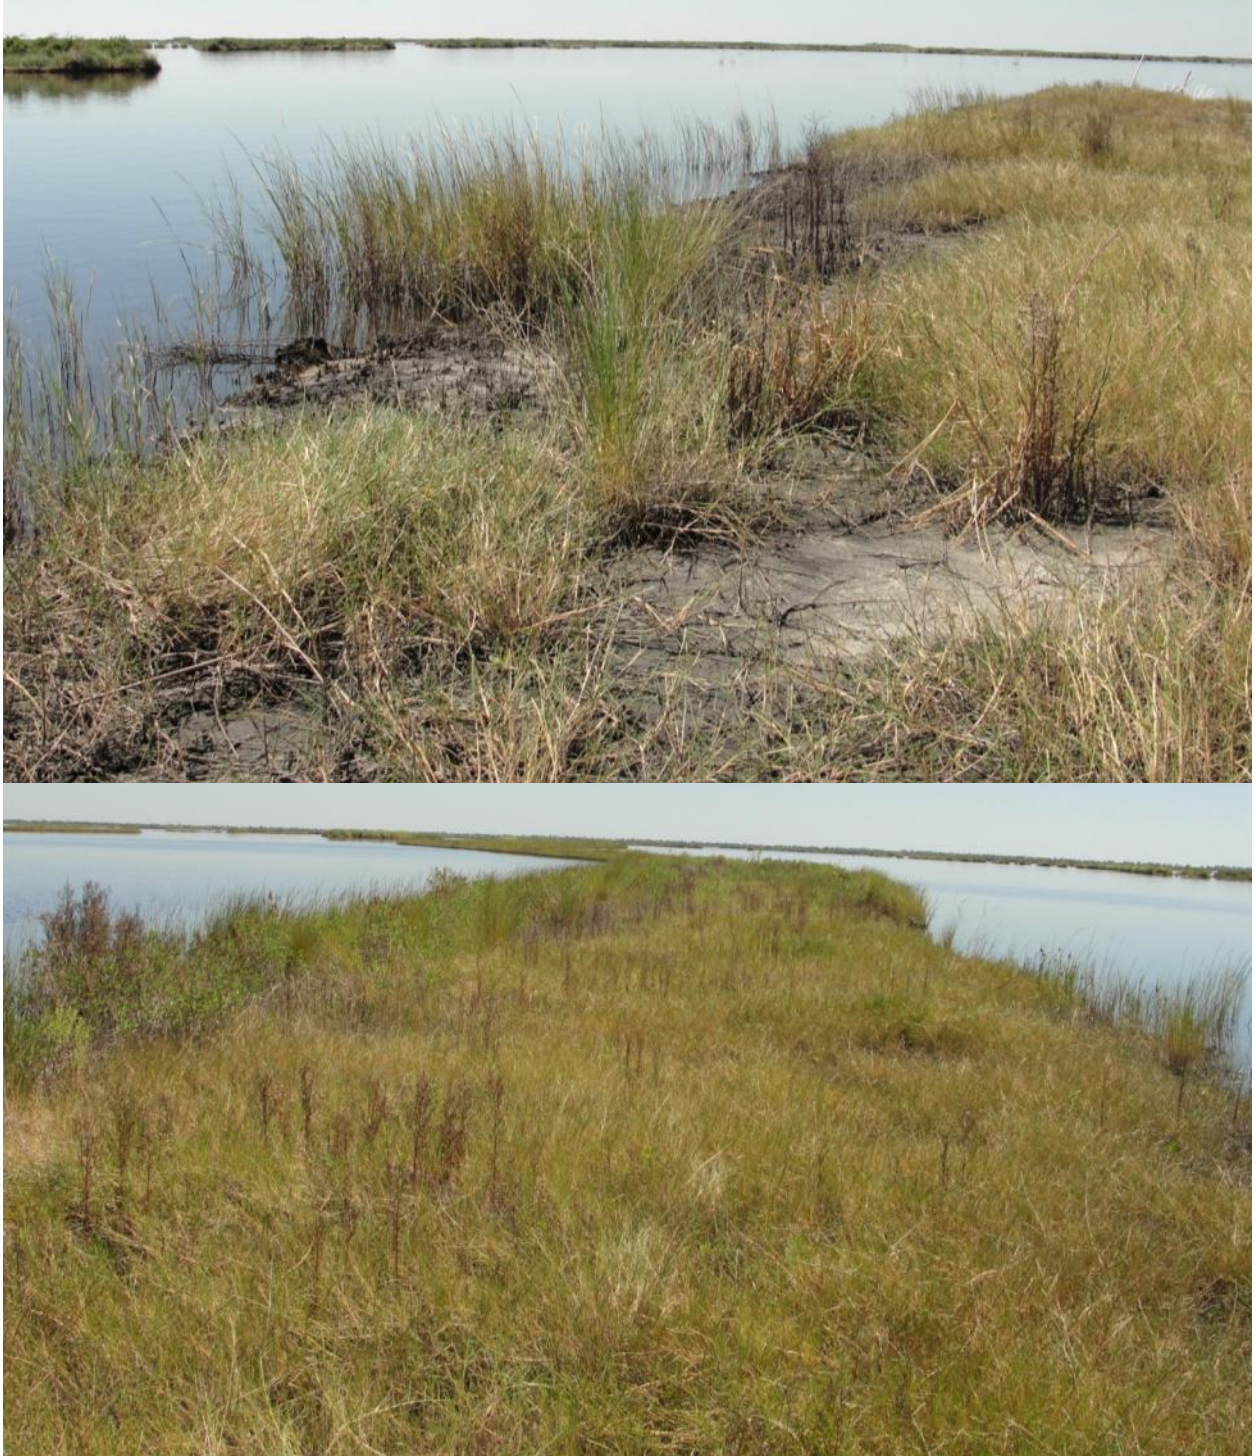
The older CU-1 Row 14A terraces continue to be in very good shape, and well covered with vegetation (below). Most of the crown cover however was from a variety of other pioneering species, mainly seashore paspalum and marshhay cordgrass (*Spartina patens*), but seashore elder (*Iva imbricata*), leafy three-square (*Schoenoplectus maritimus*), goldenrod (*Solidago* sp.) and sedges (*Cyperus* spp.) were also present, as well as saltmarsh aster (*aster tenuifolius*), cattail (*Typha* spp.), camphorweed (*Pluchea camphorata*) and marsh morningglory (*Ipomoea sagittata*), and walter's millet (*Echinochloa walteri*). The smooth cordgrass at the toe of this row's segments actually looked in poor shape, and the cover it provided was sparse along some edges.

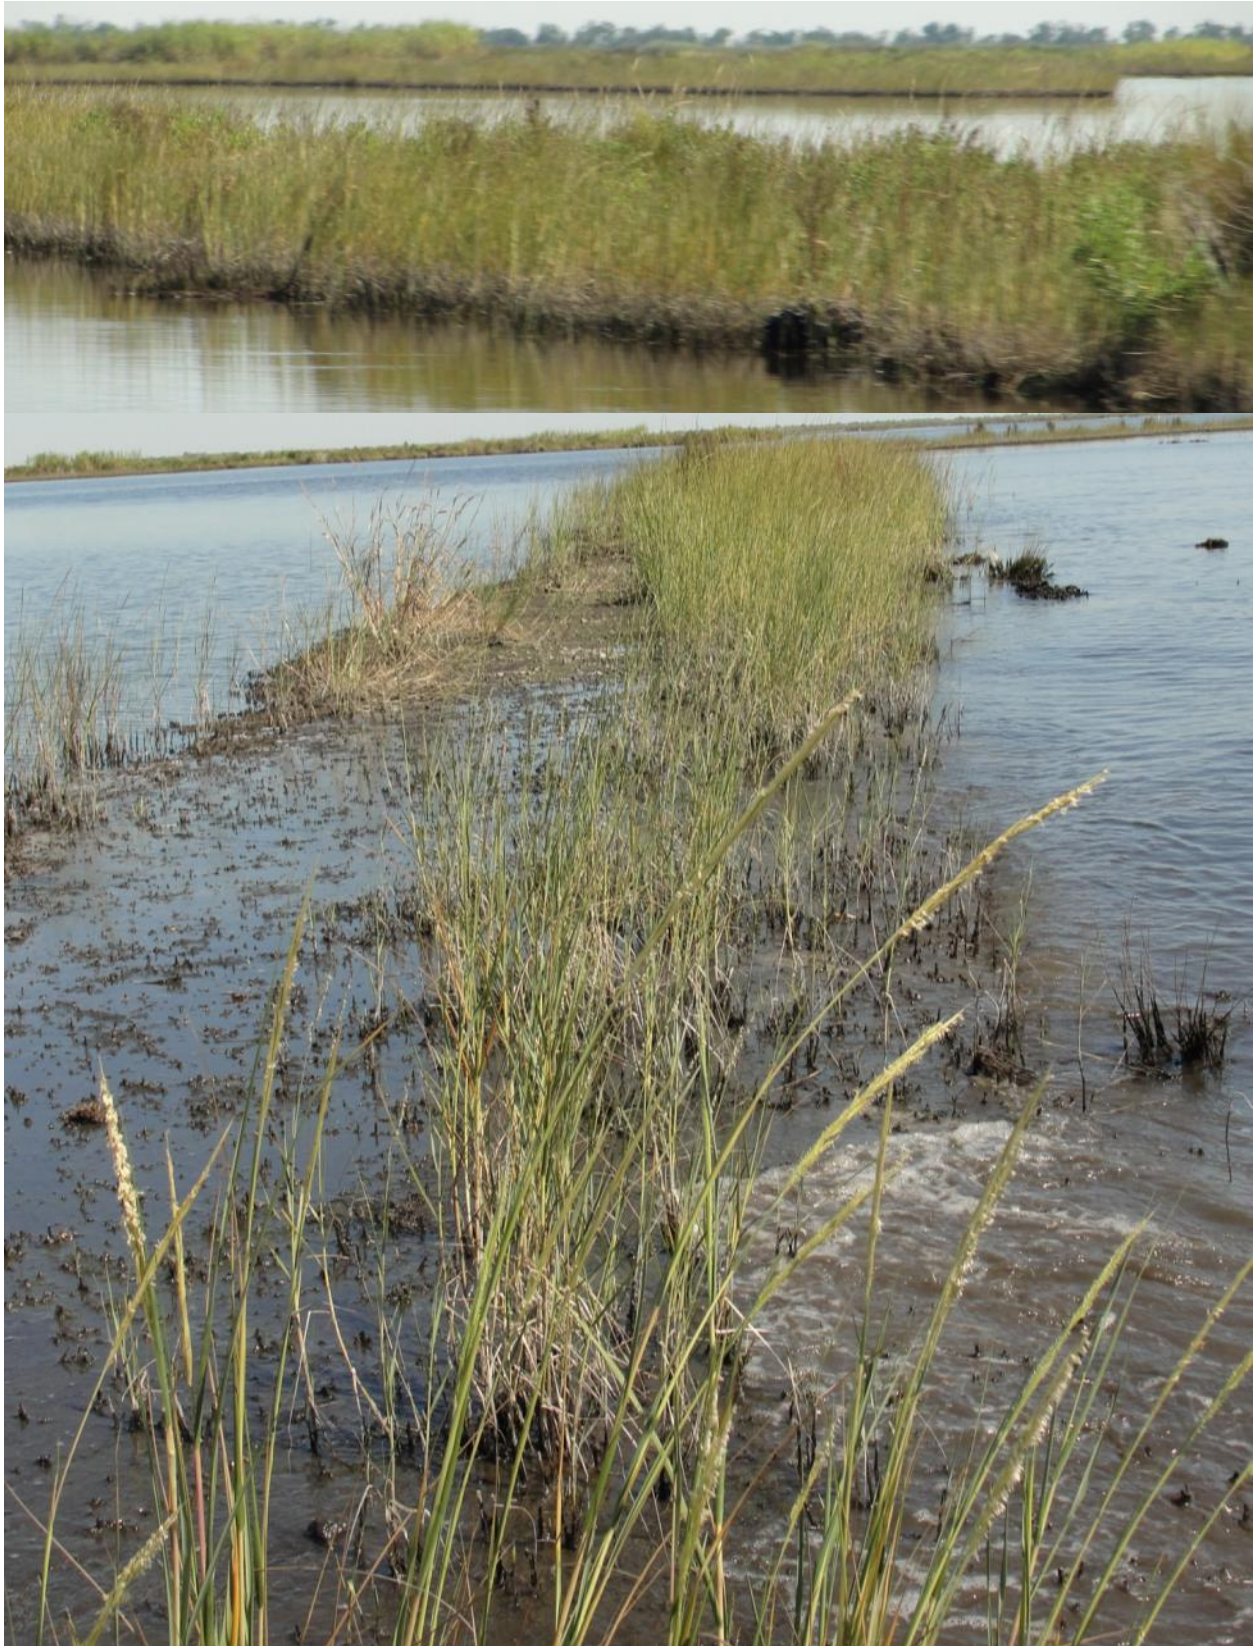
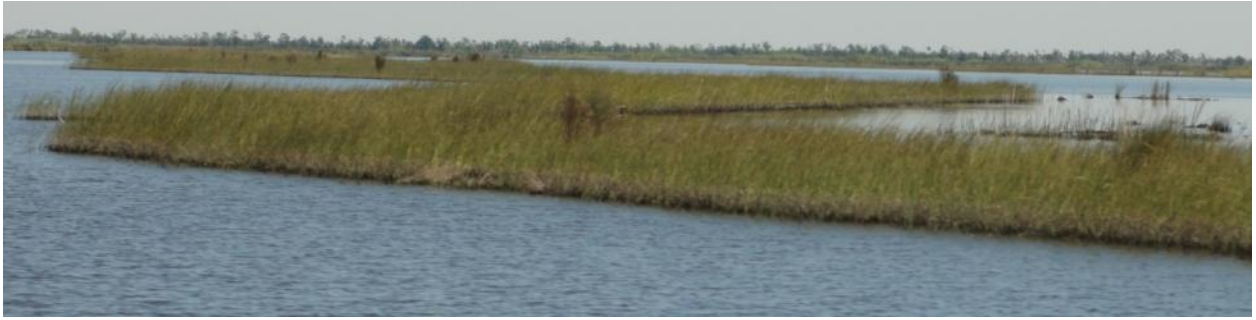
Overall, the southern rows of CU-1 group looked stable though some had obviously narrowed. There were some areas of loss observed, but there was no discernable pattern that might explain the loss, or why the smooth cordgrass was not recovering well on some segments or in spots, but on others, though providing thin cover, the individual plants looked fairly robust.

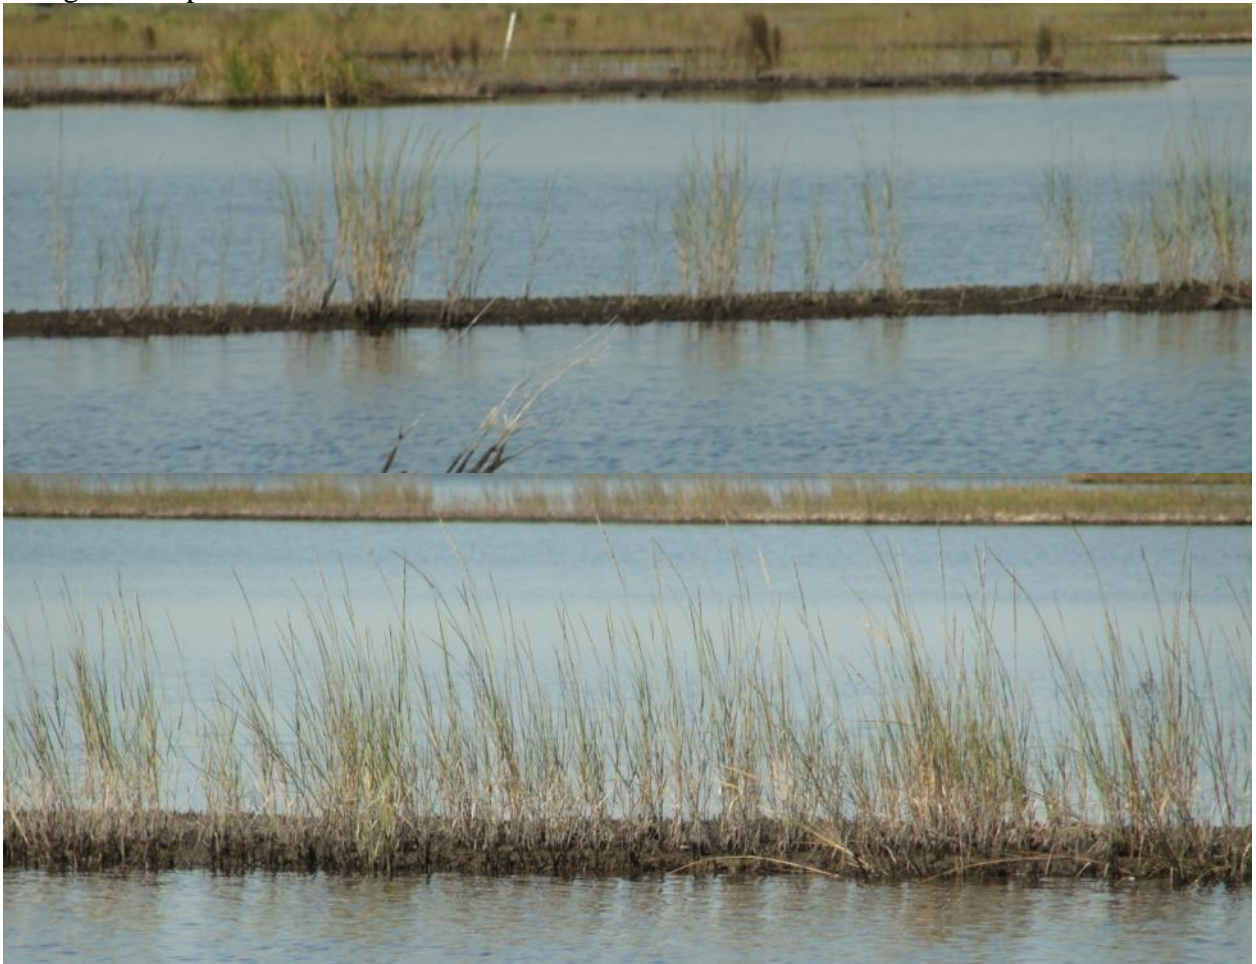
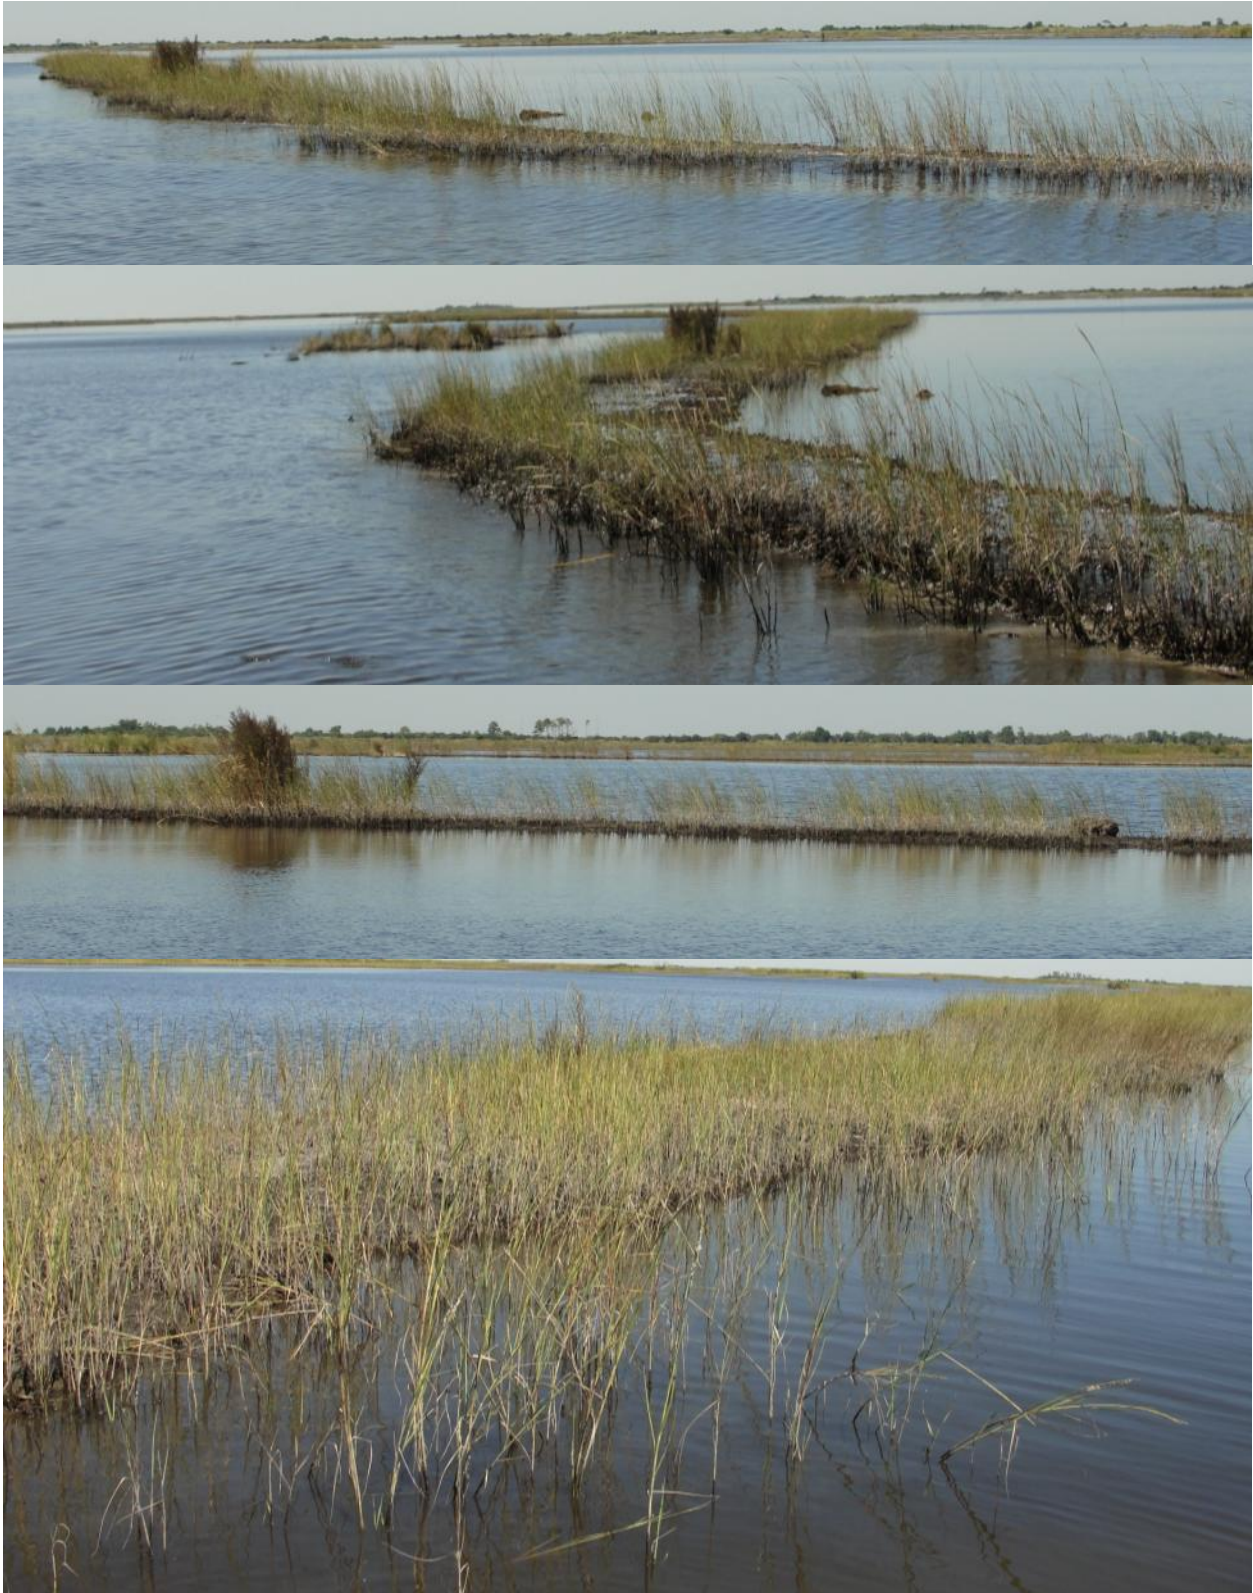
Continuing north, the survival and cover on the CU-1 terraces was found to vary quite a lot. Many terrace segments were much narrower and had poor to no cover, but there were other segments where the cover was good and the terraces retained their width. Overall though, there were only a few sites found where individual smooth cordgrass plants looked as robust as those seen to the south. It almost appeared that some plantings were just beginning to re-emerge and expand the cover.

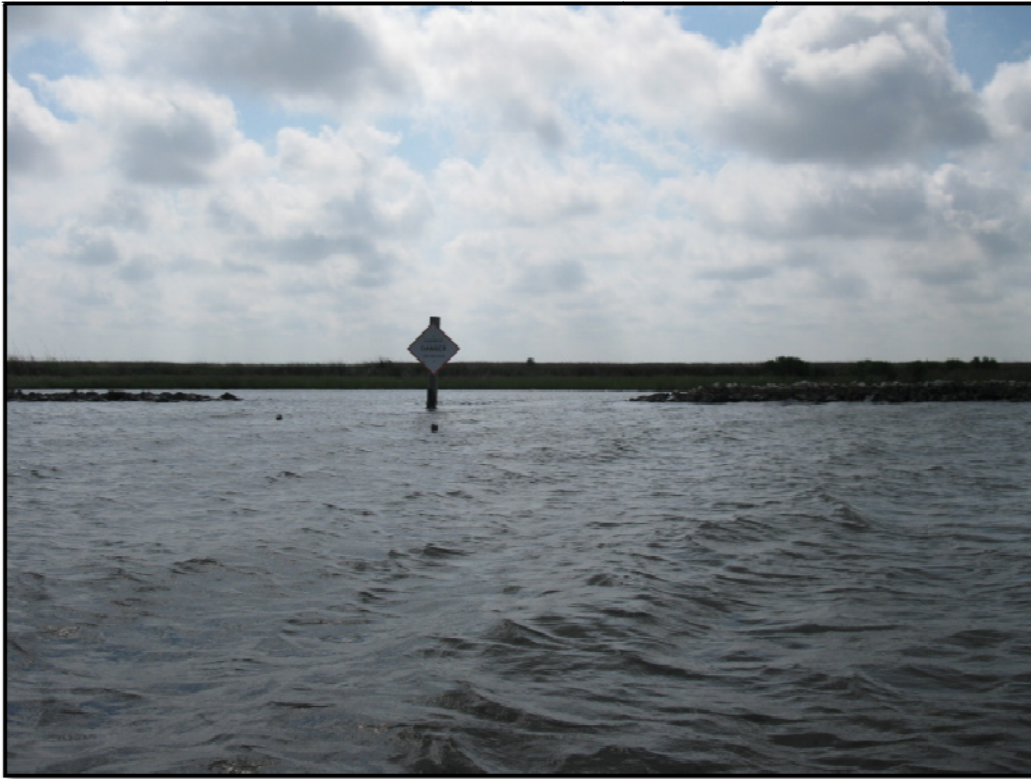
The rock dike is in good condition since completion of construction. There are a few low areas of rock dike that were identified with GPS coordinates and which will be monitored in future inspections for any changes that may be detrimental to the project and require maintenance. Areas behind the rock dike are beginning to show signs of accretion. Vegetation behind the rock dike along the northern reaches has grown out and is touching the back side of the dike. (Photos: Appendix B, Photos 1 - 2)

Photo No.1 -Typical fish dip along rock dike with warning sign

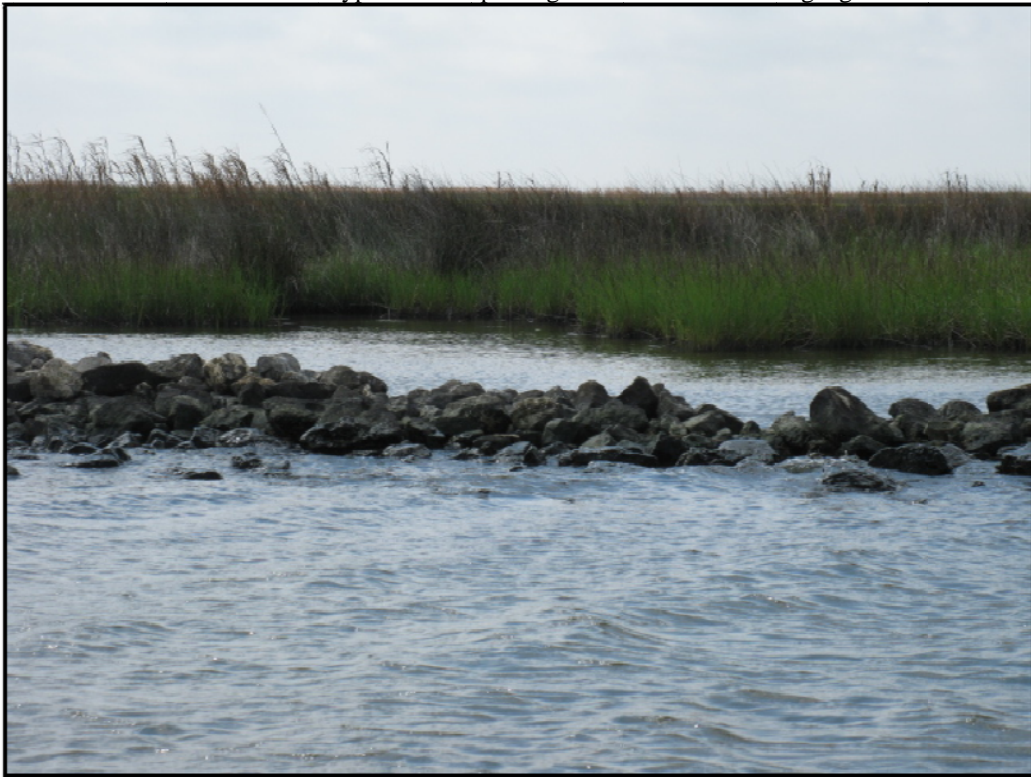
Photo No. 2 -Typical rock dike showing accretion between dike and shoreline

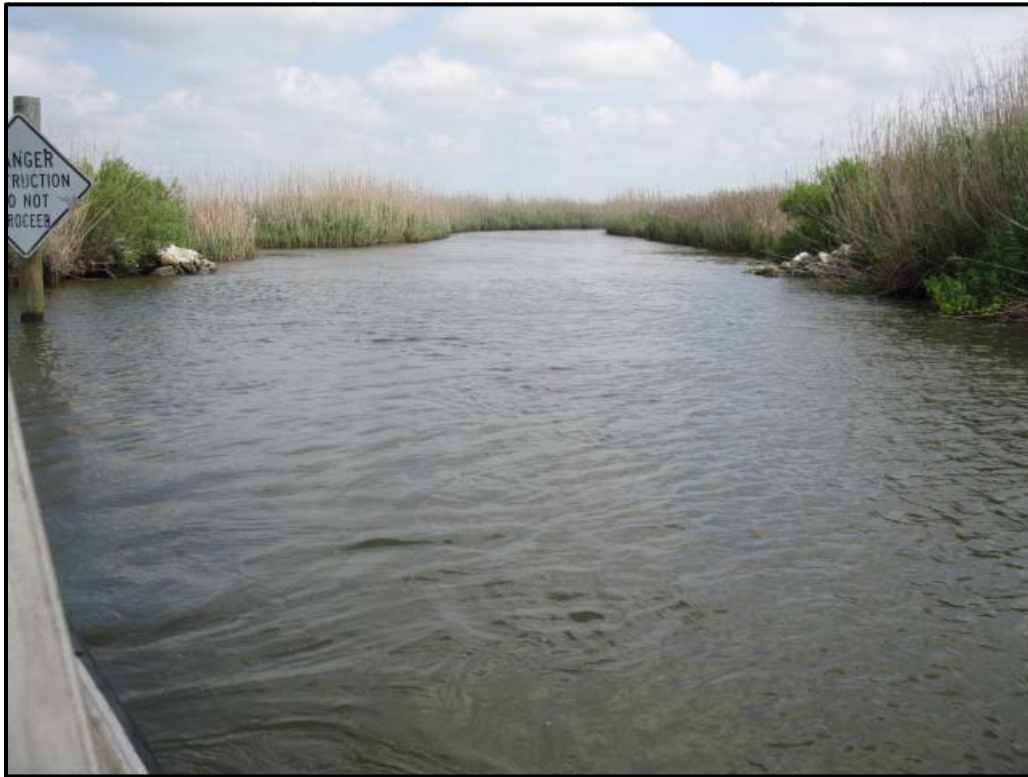
Photo No. 3 – Pines Ridge Weir

The rock weir is in good condition after being rebuilt after Hurricane Rita. No signs of erosion are evident around the bank slopes. (Photos: Appendix B, Photo 3).
